4-Point Inspection Form

Address Inspected: 1234 Country Club Drive, Anywhere, FL 55555

Actual Year Built: 1960 Date Inspected: 02/02/2023

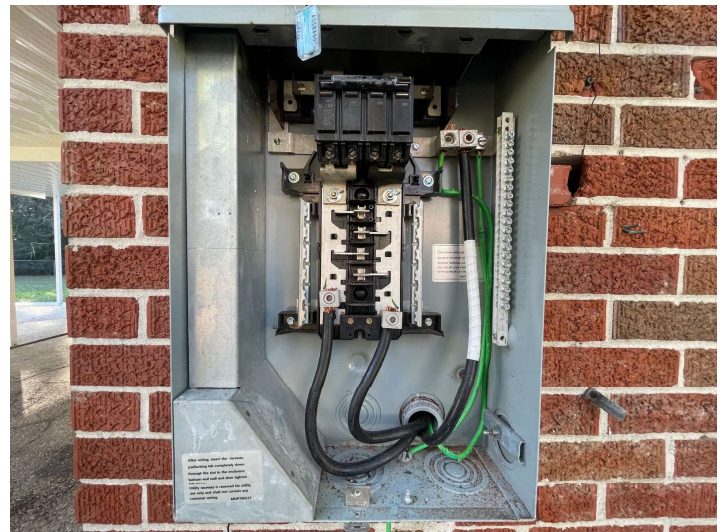
Main Panel (200 amp)

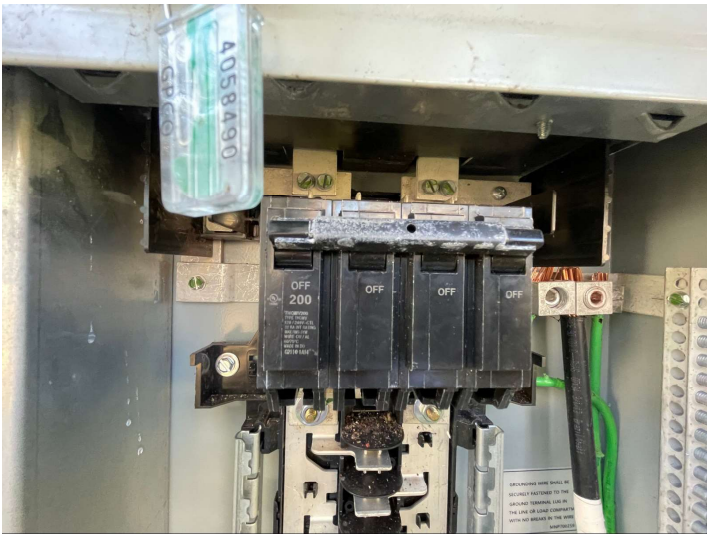
Main Panel (Main Disconnect)

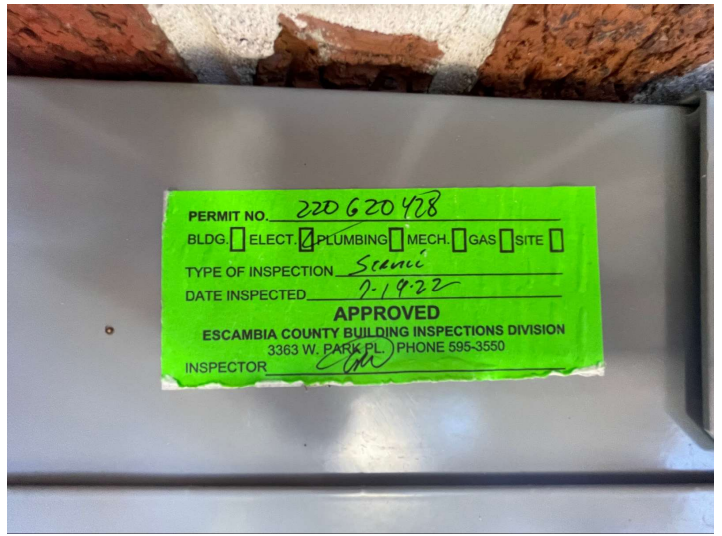
New panel installed July 2022

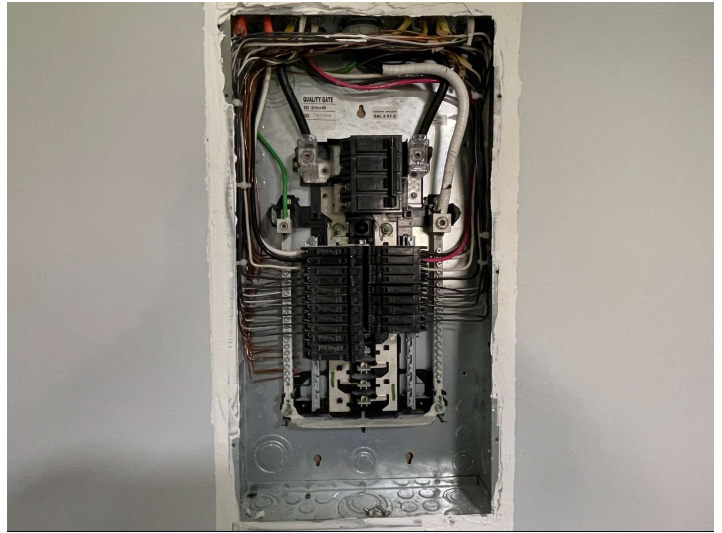
Sub-Panel (200 amp with disconnect)

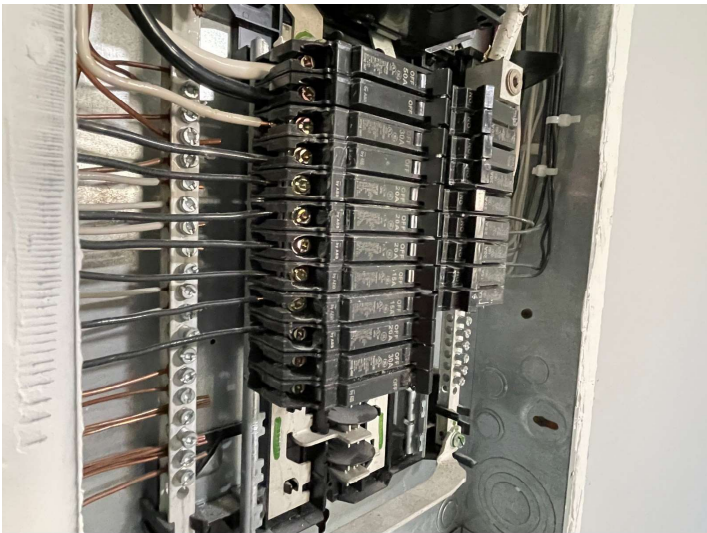
Left breaker view (All branch circuits are copper wire)

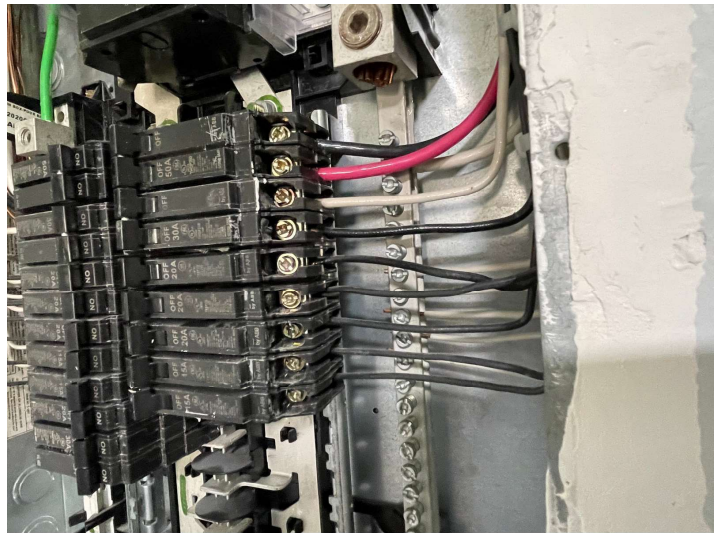
Right breaker view (All branch circuits are copper wire)

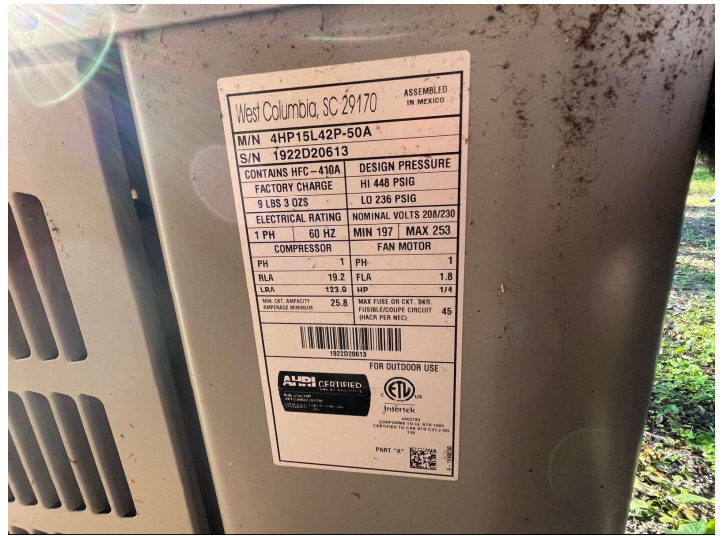
Condenser Unit (Manufactured April 2022)

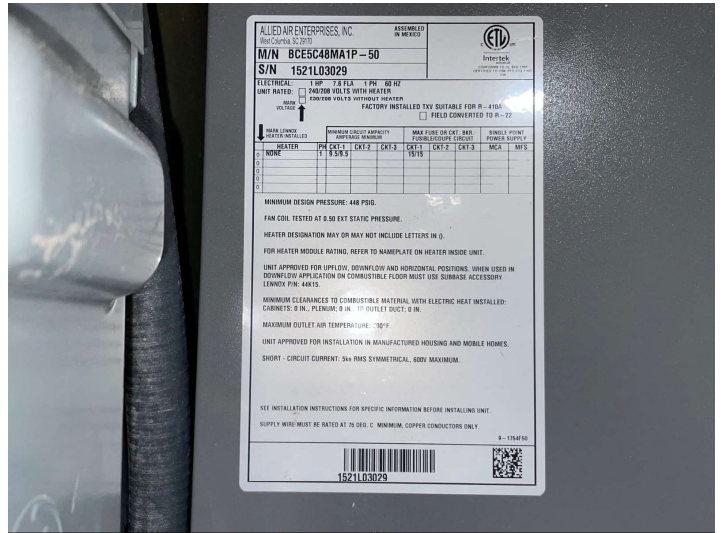
Air Handler (Manufactured November 2021)

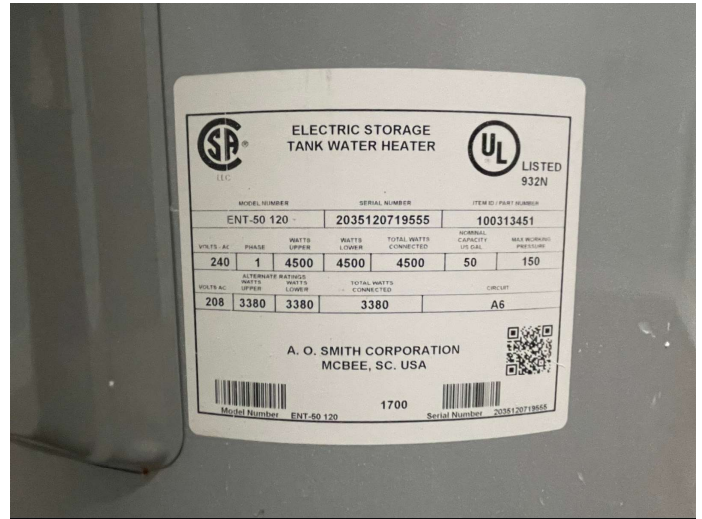
Water Heater (Manufactured in Sept 2020)

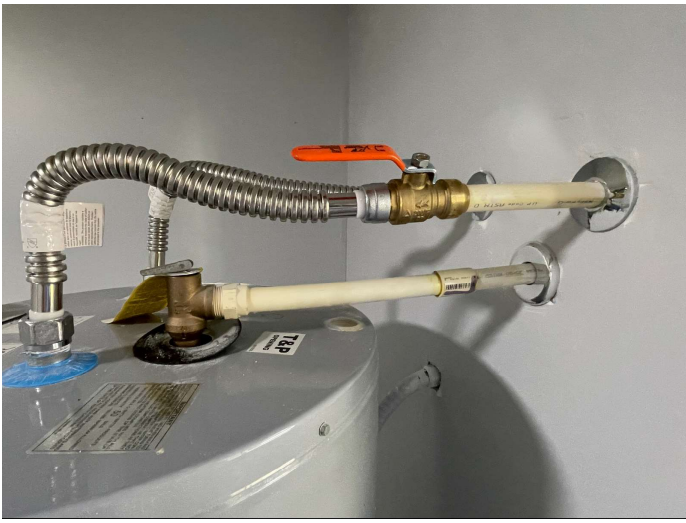
TPR Valve Drain Line (Supply lines CPVC)

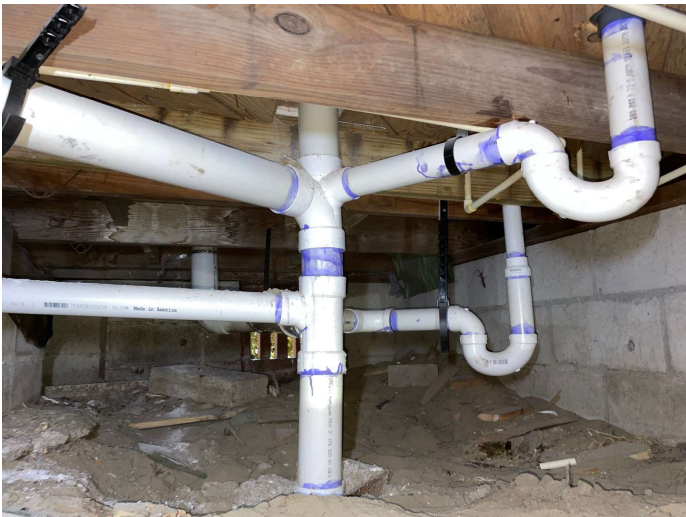
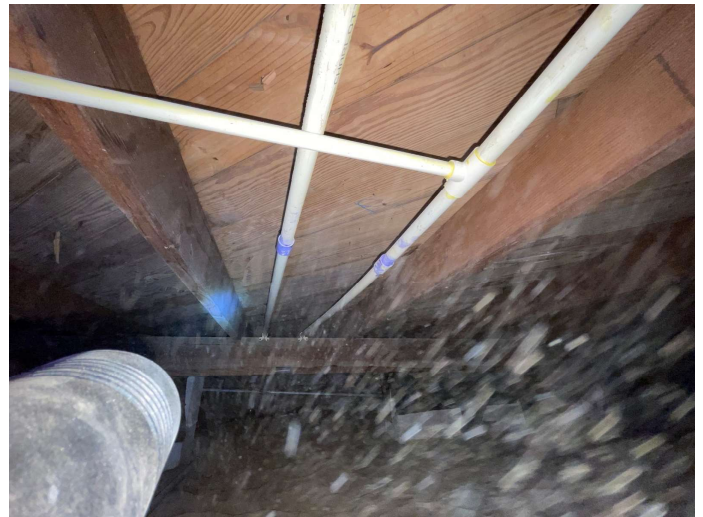
Plumbing – PVC/CPVC

Whole house converted from galvanized to CPVC in 2022. Drains upgraded from cast iron to PVC in 2022.

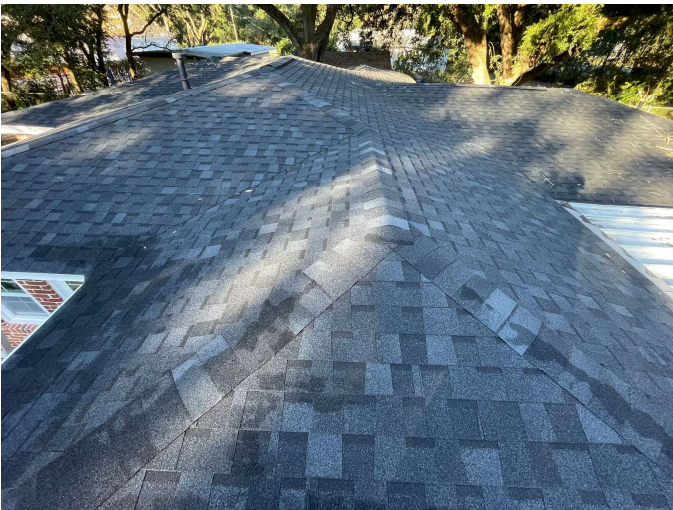
Predominant Roof - Architectural Shingle (Front to Back View)

Whole house was re-roofed in June 2022. Shingle in new condition.

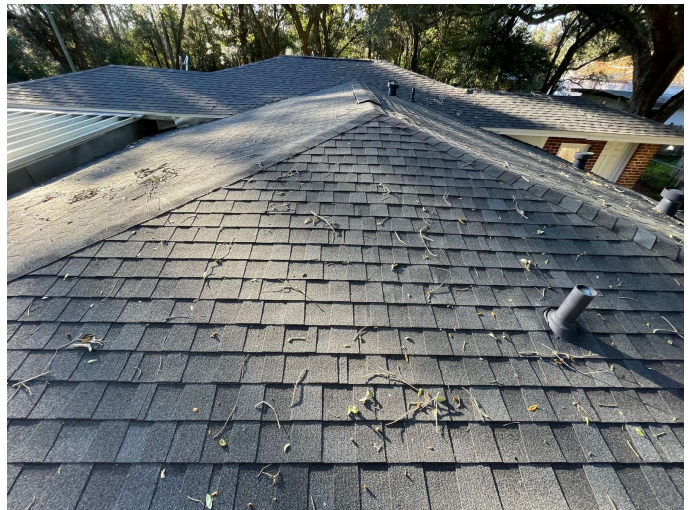
Predominant Roof - Architectural Shingle (Side View, Right to left)

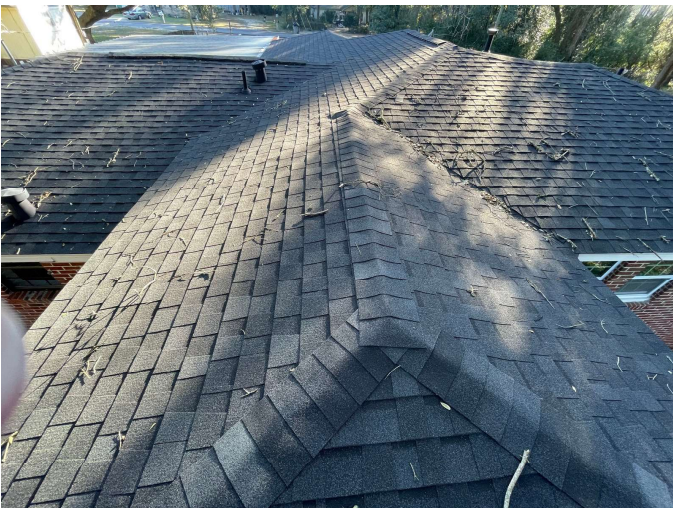
Predominant Roof - Architectural Shingle (Rear to Front View)

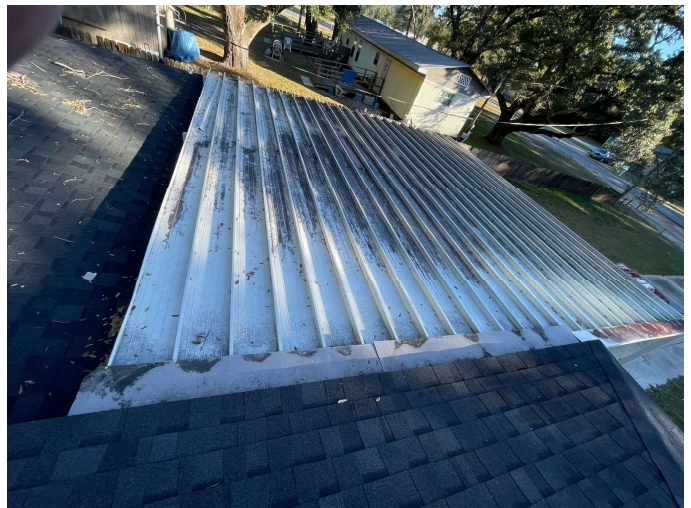
Aluminum Carport attached to the front eave of house. (Good Condition)
