# Rolfs Home Inspection LLC

**January 4th 2023, 12:00 pm**

**BUILDING ADDRESS:** 1234 Country Club Drive  
**CITY:** Anywhere  
**STATE:** Florida  
**ZIP CODE:** 55555  
**INSPECTION DESCRIPTION:** Whole Home  
**SQUARE FOOTAGE:** 1735

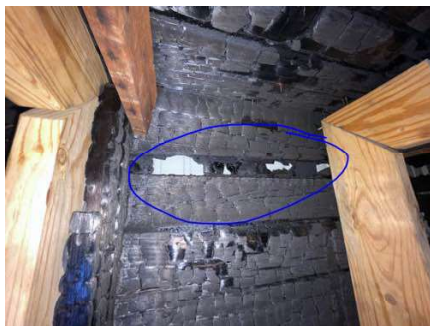
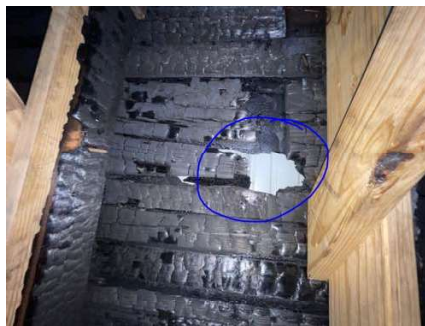
At some cut point, there was a fire in the attic of this house. The wood rafters and sheathing material were burnt pretty bad. It appears, 2 x 6 boards were added to the burnt rafters to strengthen. The sheathing material was not replaced after the fire. The metal roof was screwed directly to the burnt sheeting material. The actual Metal roofing can be seen in places from the attic through the burnt sheeting material.

**At some cut point, there was a fire in the attic of this house. The wood rafters and sheathing material were burnt pretty bad. It appears, 2 x 6 boards were added to the burnt rafters to strengthen. The sheathing material was not replaced after the fire. The metal roof was screwed directly to the burnt sheathing material. The actual Metal roofing can be seen in places from the attic through the burnt sheathing material.**

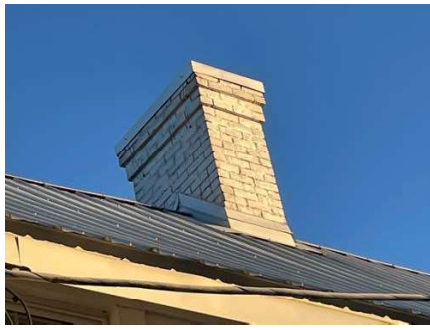
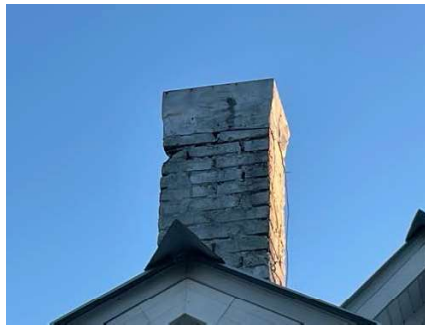
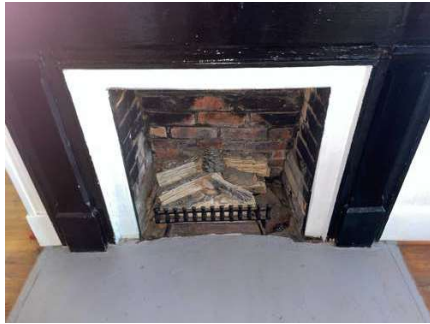
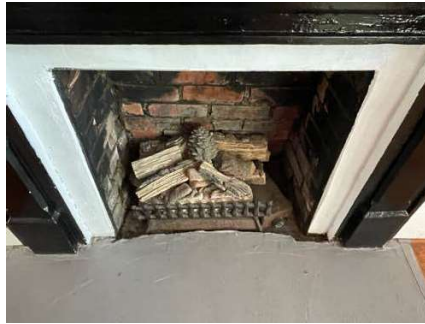
There are two chimneys penetrating the roof of this house. Neither chimney was inspected, due to the steep pitch of the roof. There are two double sided fireplaces connected to the main chimney. One upstairs and one downstairs. Both fireplaces are very old and do not appear to be in good working condition. Inspector recommends only a small gas or electric heater be inserted into the firebox. If there is ever any intention to start an actual fire, inspector recommends a full fireplace inspection by a qualified contractor. The second chimney/fireplace has apparently been framed around inside house. It cannot be seen from the interior of the house.

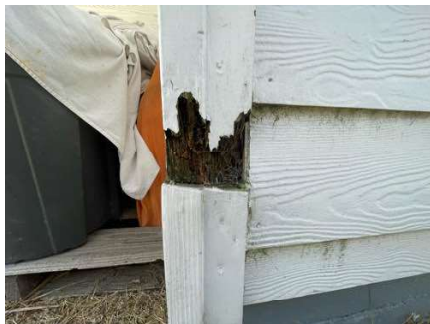
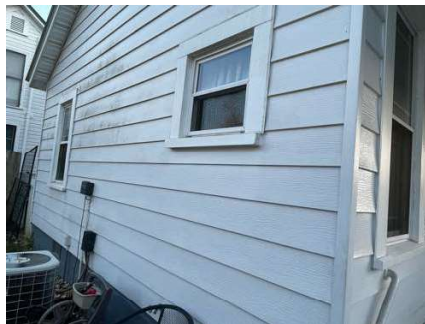
This house has a couple different siding materials. A good bit of the front is Hardi Plank type concrete board. The rest of the house is metal/aluminum siding. Both appear to be in good condition. One piece of wood corner trim has wood rot towards the bottom.

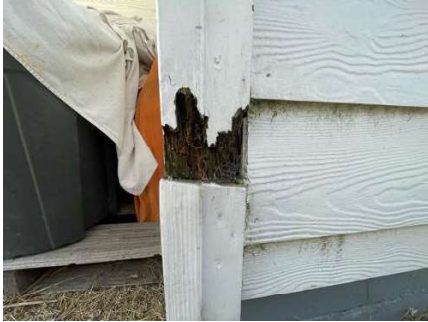
Most of the trim on this house appears to be metal/aluminum siding and is in good condition. One corner has a piece of wood trim that has rot at the bottom. This piece of trim will need to be replaced and repainted.

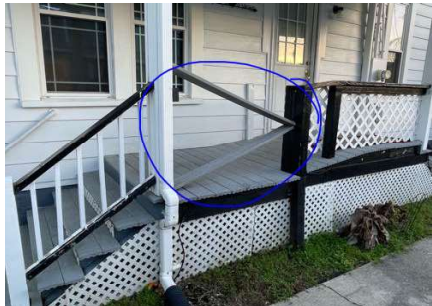
There's a small wooden deck on the left side of the house. The exterior door from kitchen exits onto this porch. The porch appears to be in good condition, but there is an insufficient handrail in one area.

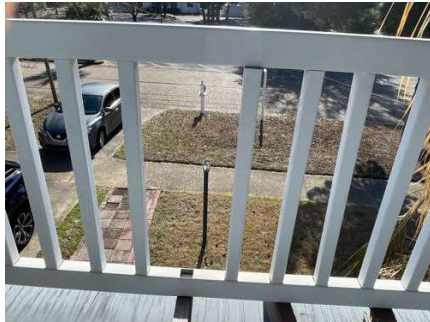
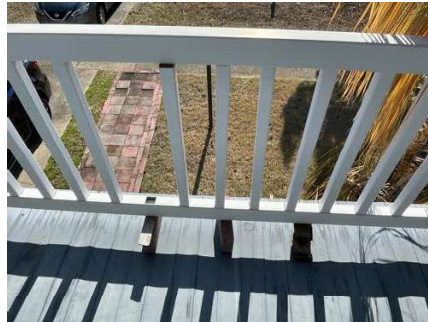
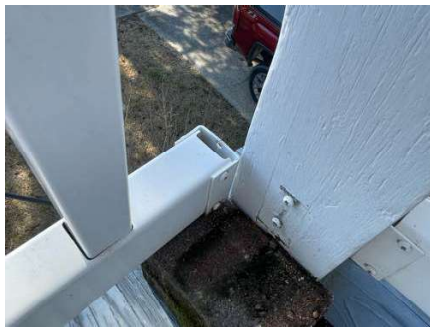
There is a wood deck upstairs on the front of the house. This deck is very old, but appears to be in good condition. The deck was observed from top and bottom and no wood rot was observed. On this upper level deck, there are several issues with the handrails. First, the handrails are only 31 inches tall and normal height is to be between 34 inches and 38 inches. Second, there is a missing baluster and blocks holding up center of handrail. The right lower end of handrail is also broken loose from pole. This could present a hazard if someone had to rely on handrail to keep from falling. Recommend evaluation by a handyman or licensed contractor to correct.

**There is a wood deck upstairs on the front of the house. This deck is very old, but appears to be in good condition. The deck was observed from top and bottom and no wood rot was observed. On this upper level deck, there are several issues with the handrails. First, the handrails are only 31 inches tall and normal height is to be between 34 inches and 38 inches. Second, there is a missing baluster and blocks holding up center of handrail. The right lower end of handrail is also broken loose from pole. This could present a hazard if someone had to rely on handrail to keep from falling. Recommend evaluation by a handyman or licensed contractor to correct.**

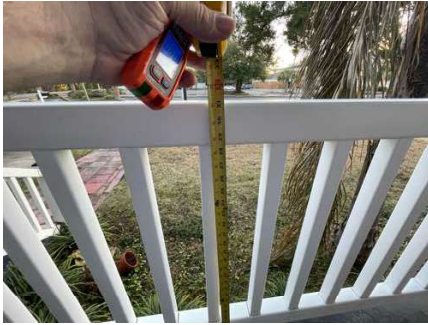
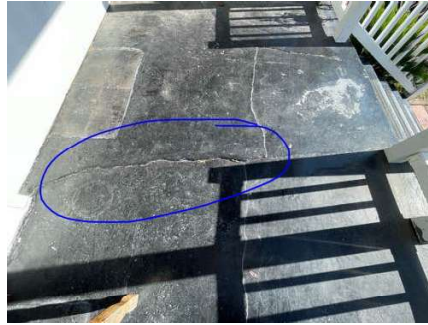
There is a covered concrete porch on the front of the house. The concrete is in fair condition for its age. There is some minor cracking, but one small area is actually raised. This could cause a small trip hazard. There are a couple of ways that this could be repaired, either framing and pour new concrete on top of original or grinding concrete smooth and filling the crack. If this is a concern, recommend evaluation by a concrete contractor. There are also several issues with the handrails on this porch. The handrails are only 31 inches tall. Standard handrails are supposed to be between 34 and 38 inches tall.

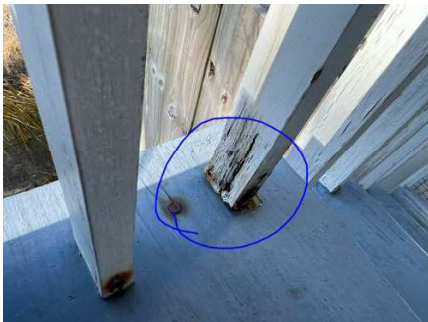
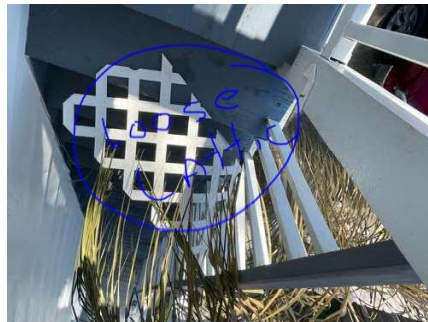
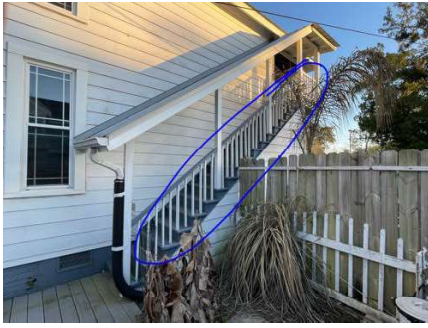
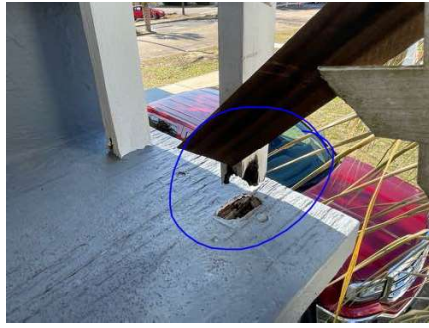
There are set of stairs leading up to the second level balcony. The steps appear to be in good condition, but there are some of the banisters that had begin to rot. The handrail itself appears to be sturdy, but the balusters themselves are not.

**There are set of stairs leading up to the second level balcony. The steps appear to be in good condition, but there are some of the banisters that had begin to rot. The handrail itself appears to be sturdy, but the balusters themselves are not.**

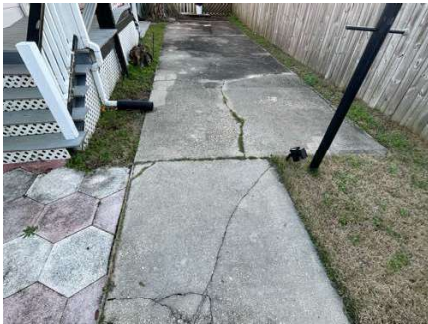
The driveways have some small cracking, but this is very common in our area.

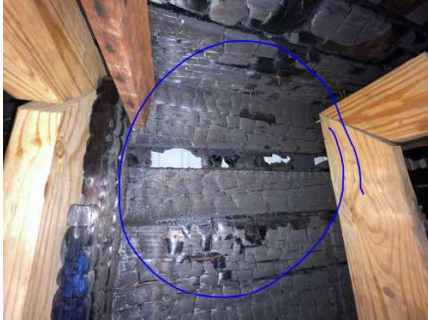
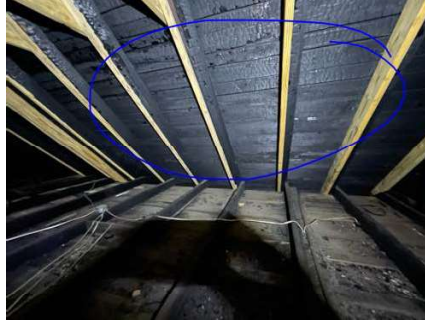
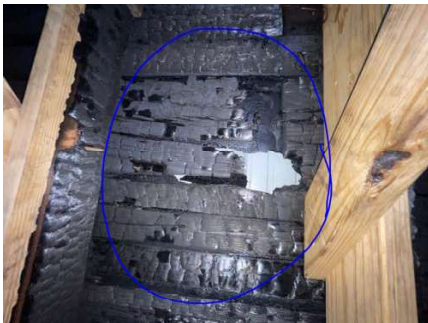
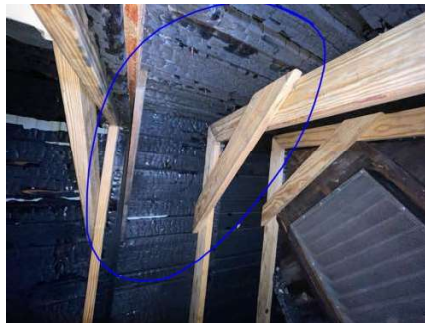
There has been a fire in the attic of this house on the second story. The fire burnt the rafters and sheathing pretty bad. New 2" x 6" boards were installed next to the rafters to strengthen. The sheathing was not replaced and is in pretty bad condition as observed by the inspector. There does not appear to be any new unburnt sheathing between the Rafters and the metal roofing. Recommend evaluation by a structural engineer or qualified general contractor.

**There has been a fire in the attic of this house on the second story. The fire burnt the rafters and sheathing pretty bad. New 2" x 6" boards were installed next to the rafters to strengthen. The sheathing was not replaced and is in pretty bad condition as observed by the inspector. There does not appear to be any new unburnt sheathing between the Rafters and the metal roofing. Recommend evaluation by a structural engineer or qualified general contractor.**

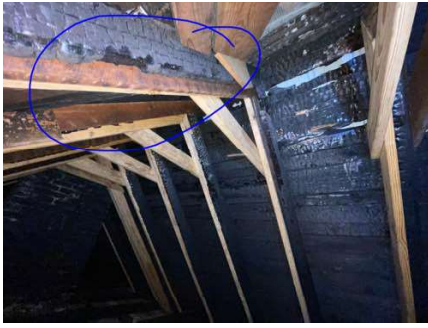
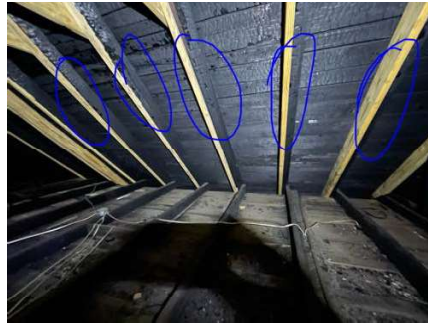
As stated before, there was a fire in the attic of this house. The original rafters were burnt pretty bad. New 2" x 6" boards were installed beside many of the burnt rafters to strengthen. Inspector does not know if this remediation was approved/overseen by a structural engineer. First, recommend discussing with seller and asking for documents and details concerning repairs. If no documents are available, recommend evaluation by structural engineer or a qualified general contractor.

**As stated before, there was a fire in the attic of this house. The original rafters were burnt pretty bad. New**

**2" x 6" boards were installed beside many of the burnt rafters to strengthen. Inspector does not know if this remediation was approved/overseen by a structural engineer. First, recommend discussing with seller and asking for documents and details concerning repairs. If no documents are available, recommend evaluation by structural engineer or a qualified general contractor.**

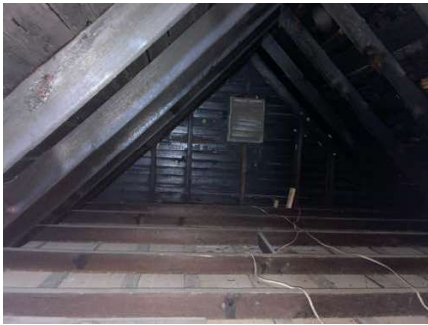
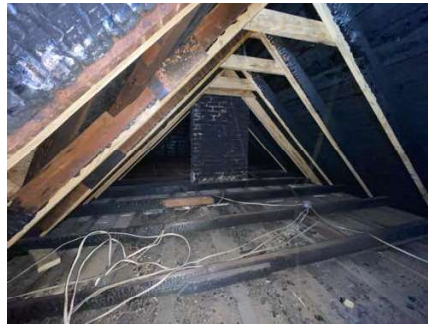
There is no insulation in the second-story attic of this house. recommend adding 12 to 15 inches of insulation to maximize HVAC efficiency.

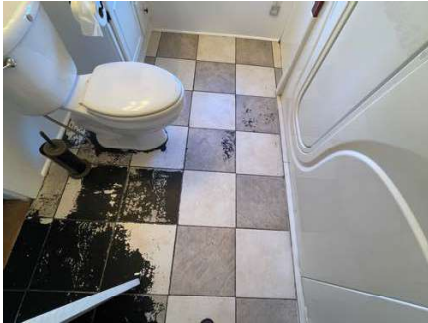
Floor is covered in porcelain or possibly ceramic tile. Tile has been painted at some point and paint is starting to peel or wear off. If this is a concern, recommend evaluation by a flooring installation contractor.

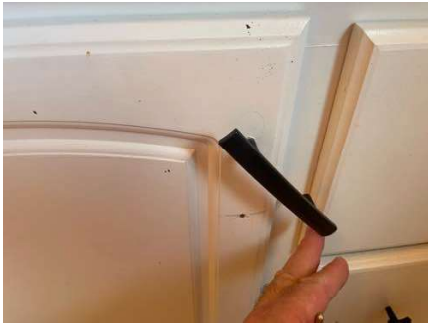
The cabinet under the bathroom sink has a screw missing from the handle. Recommend repair / replacement by a homeowner or handyman.

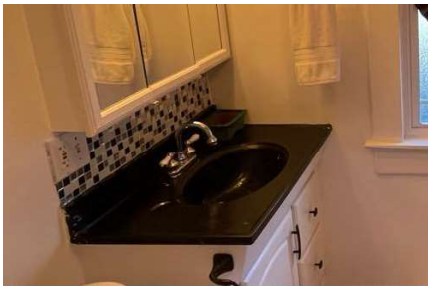
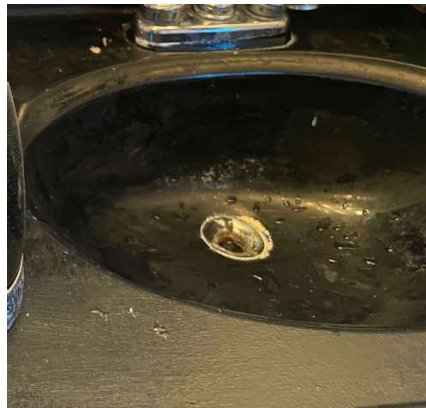
This bathroom has a hard surface countertops sink which has been painted. Paint has been scratched in several areas. The drain stopper is missing and needs repair. Recommend evaluation by a handyman or licensed plumber.

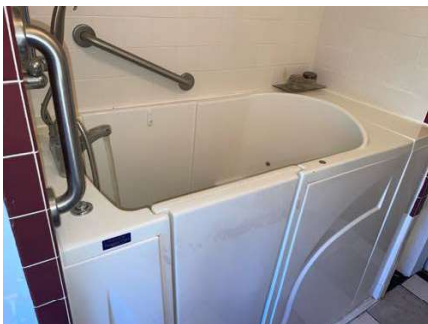
This bathroom has a walk-in bathtub in fair condition. The unit appears to work as intended, inspector filled 1/2 full to check seal. Door seal appears to work fine has no leakage was observed.

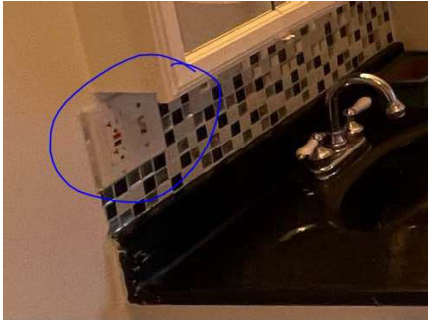
The GFCI receptacle tests to have an open ground and will not trip with inspectors tester. The light over the sink is also controlled by this GFCI receptacle. Receptacle will trip with test button on unit. The light goes off along with the receptacle. Do not believe there is GFCI protection for this receptacle next to sink. recommend evaluation by a licensed electrician.

**The GFCI receptacle tests to have an open ground and will not trip with inspectors tester. The light over the sink is also controlled by this GFCI receptacle. Receptacle will trip with test button on unit. The light goes off along with the receptacle. Do not believe there is GFCI protection for this receptacle next to sink. recommend evaluation by a licensed electrician.**

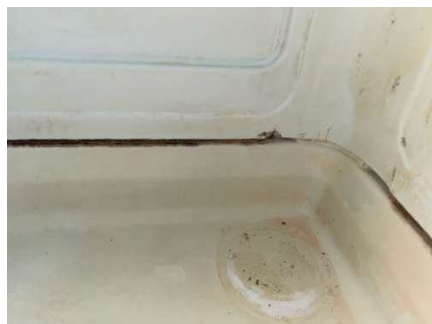
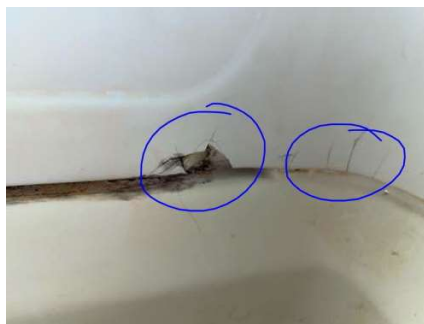
There is a small fiberglass shower stall in fair condition. There is several small cracks around the bottom edge of shower wall where it connects to the pan. This could be repaired with caulk, but will not last forever. If this is a concern, recommend evaluation by a licensed plumber or a general contractor. The shower door is in fair condition with some cosmetic issues at the very bottom.

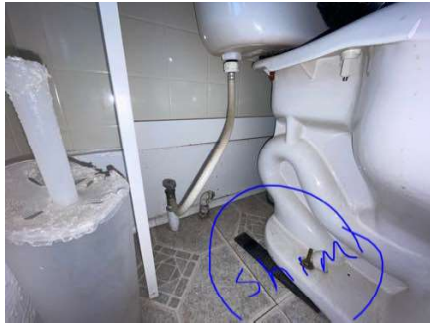
Toilet is loose from the floor and needs to be reset and tightened. There is currently a shim pushed under to help stabilize this toilet.

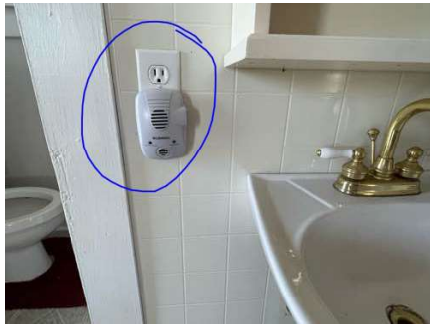
The receptacle next to sink is not GFCI protected. Recommend evaluation by a handyman or licensed electrician.

**The receptacle next to sink is not GFCI protected. Recommend evaluation by a handyman or licensed electrician.**

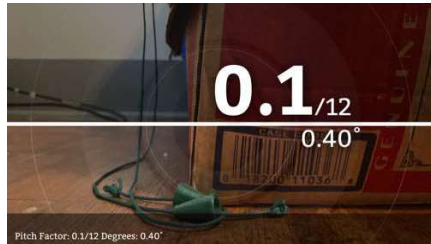
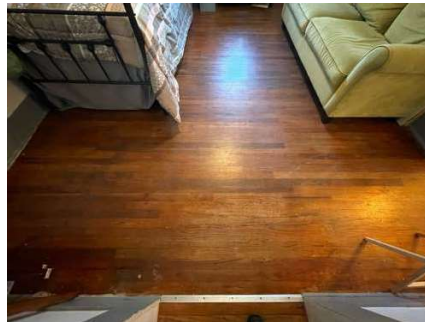
Original hardwood floor in fair condition. Although the floor appears to go downhill as you enter the room moving to the back, A level shows very little slope.

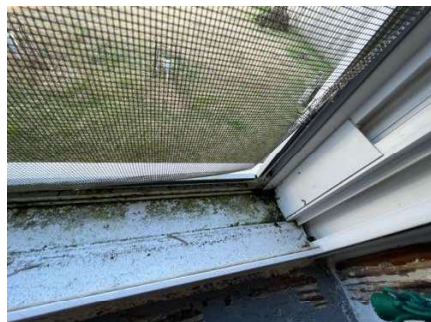
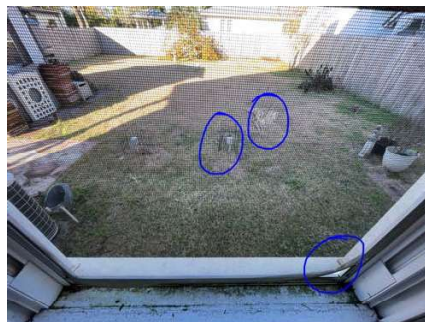
Window is vinyl clad, double pane, double hung units in good condition. No evidence of vacuum seal failure. The screen is torn in a couple of places.

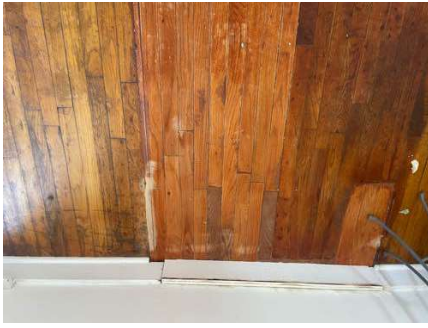
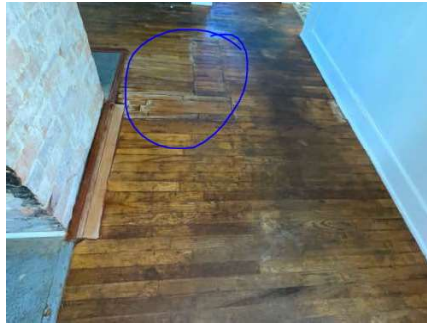
Flooring is solid hardwood in fair condition. Has been patched in several places around the fireplace.

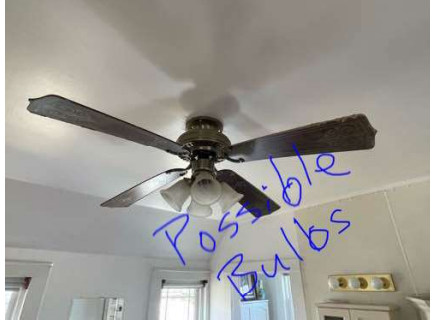
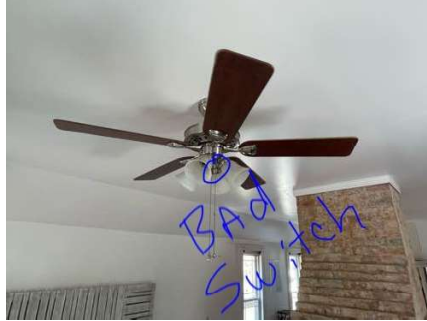
There are two light kits attached to ceiling fans in this room. The light over the bed does not work due to a bad switch installed on the light kit itself. The second light in this room does not appear to work. Maybe expired bulbs. Recommend changing bulbs first and if this does not work, evaluation by a handyman or licensed electrician.

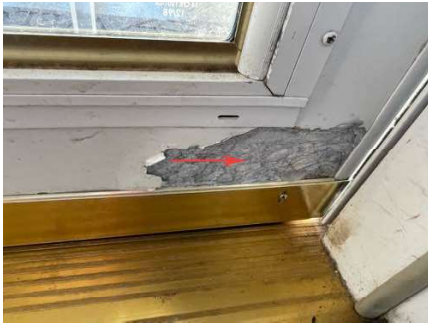
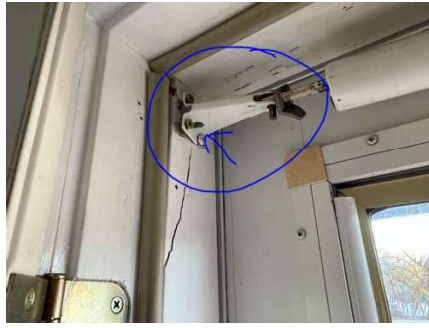
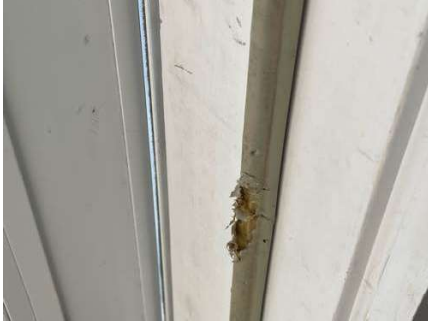
There's a metal clad exterior door with large oval window in very good condition. The storm door attached to this door frame has a couple issues. The paint appears to be peeling in several places inside and outside. The door closing shock absorber has also pulled its screws into the door frame loose. The door weatherstripping is also torn in a couple places. Recommend evaluation by a handyman.

The exterior door has a double lock set deadbolt. Recommend replacing inside lock set with hand turn knob for fire exit and safety.

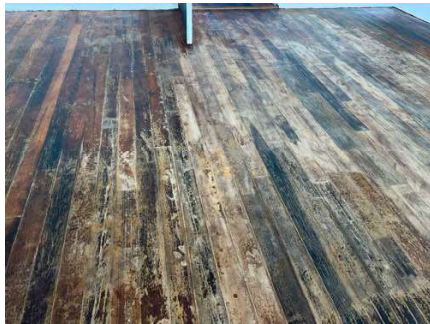
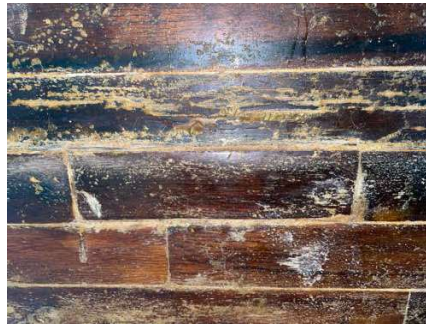
The hardwood floor in this area appears to be in poor condition. There are some raised areas that have appeared to been exposed to excessive moisture. There's a strong pet urine smell apparently coming from the wood floor. Recommend evaluation by a flooring refinishing contractor.

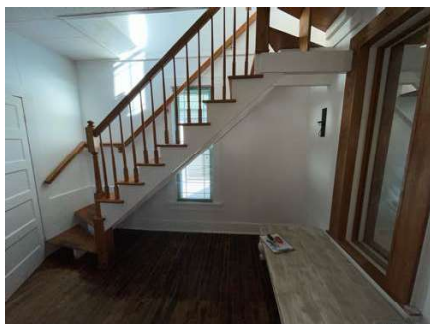
Stairs appear to be in good condition. Treads and handrails meet minimum standards. Stairs and handrails appear to be very solid.

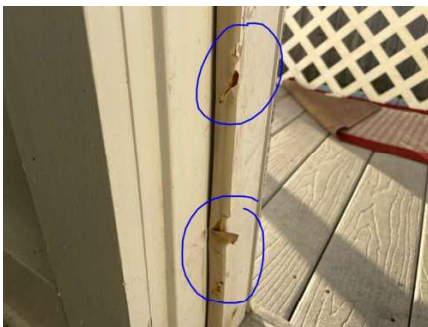
Metal clad exterior door with half light in good condition. Weather seal is torn in several places. May need to replace at some point. This exterior door has a double lock set deadbolt. Recommend replacing inside lock set with hand turn knob for fire exit and safety.

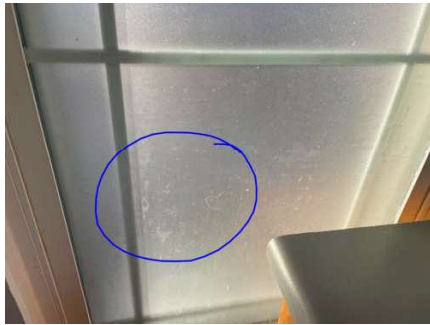
Windows are vinyl clad, double pane, double hung units in good condition. No evidence of vacuum seal failure. There is a privacy texture on these windows and it is starting to peel.

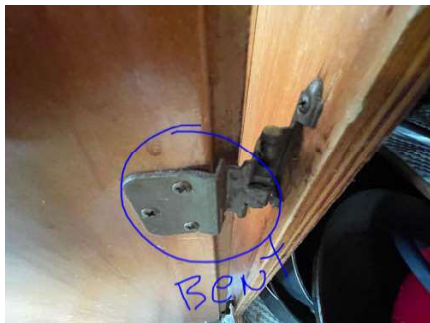
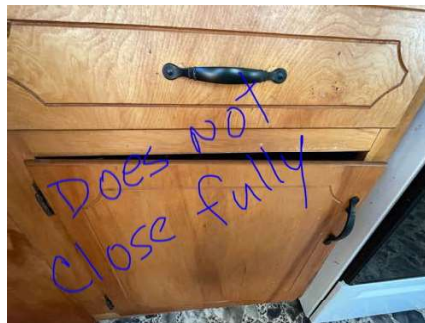
All cabinet doors and drawers were tested and work as intended with one exception. One door has bent hinges. These hinges will need to be replaced. Recommend evaluation by a handyman.

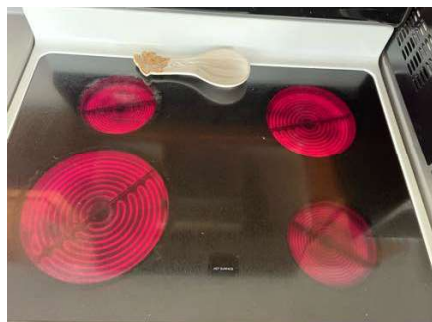
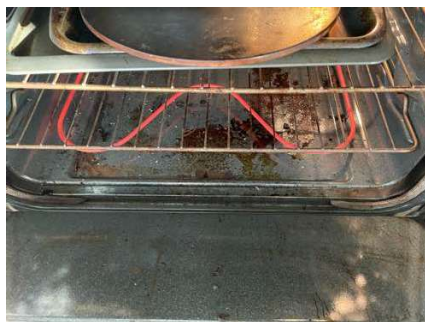
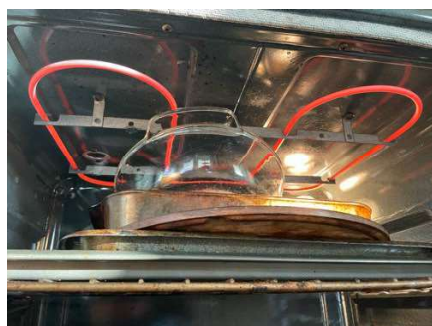
Stove and oven combo was tested. All burners including oven and broiler work as intended. Microwave had no power and was not tested.

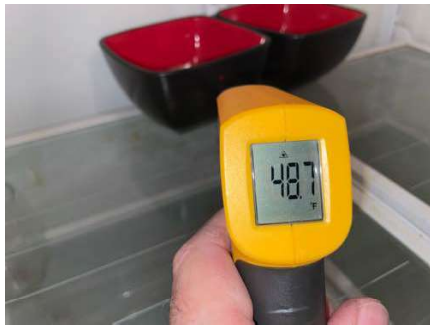
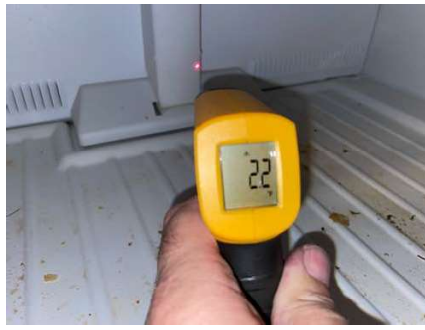
Refrigerator was unplugged when inspector arrived. Inspector plugged refrigerator in and tested and then unplugged refrigerator again. Refrigerator temperature tested at 48.7°F and the freezer tested at 2.2°F. deep freeze was also tested and it was -4°F.

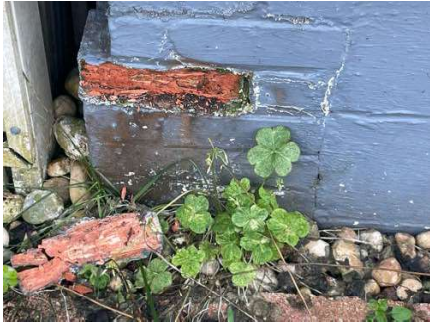
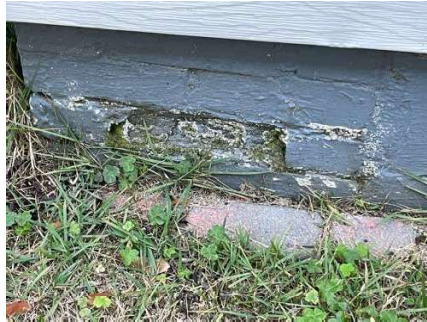
From the exterior, the foundation appears to be in good condition. There is a small amount of brick starting to deteriorate from age. House was built in 1900, so this is expected. There is no access to the house's crawlspace.

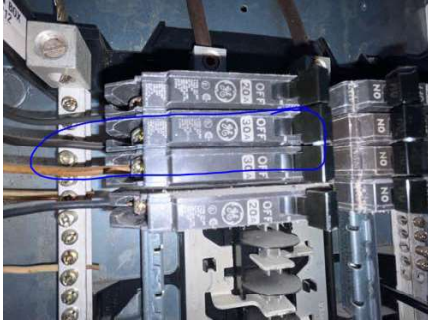
All breakers appear to be in good condition. One breaker in upstairs subpanel, is wired incorrectly. There are two 110 V circuits connected to one 220 V breaker. This needs to be corrected for safety. Recommend evaluation by a licensed electrician.

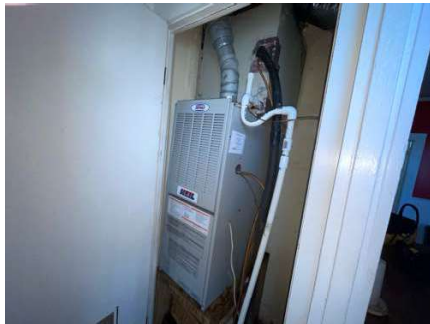
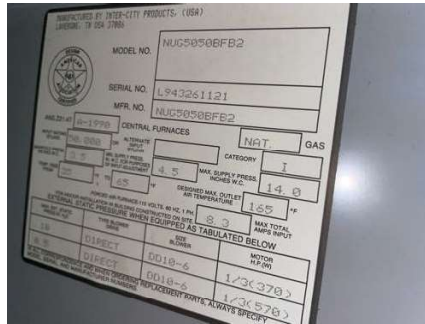
Heating system could not be tested, pilot light was not activated.  
Air Handler was manufactured August 1994, may be nearing end of life.  
Recommend evaluation by a License HVAC contractor prior to closing.

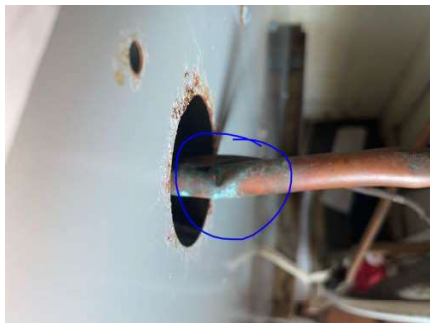
Visible ductwork and piping appears to be in good condition. One small kink noted in natural gas line to central furnace.

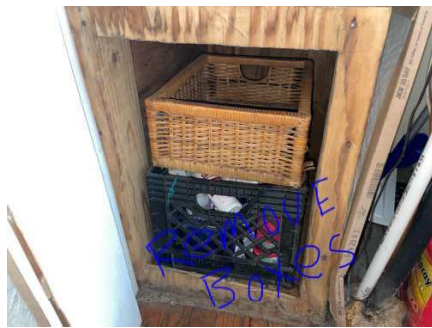
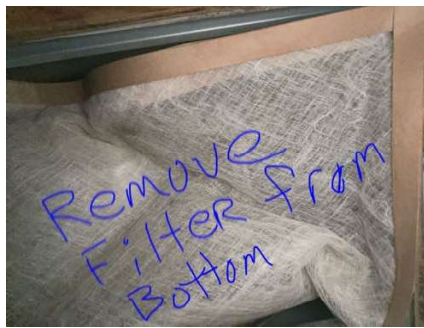
One air filter is stuck up in the bottom of the air handler. Needs to be removed. There is also several boxes of things stored under air handler causing reduced airflow. Recommend removing boxes to open airflow.
