ROLFS HOME INSPECTION LLC

ROOM-BY-ROOM RESIDENTIAL

12345 Clubhouse Drive
Anywhere, FL 99999

JULY 5, 2023

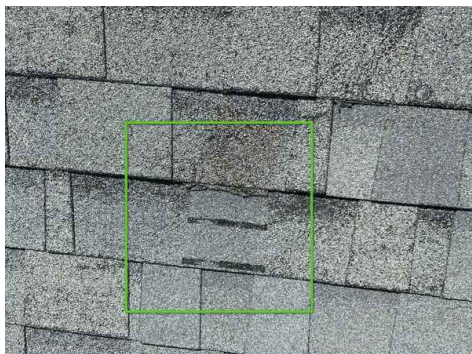
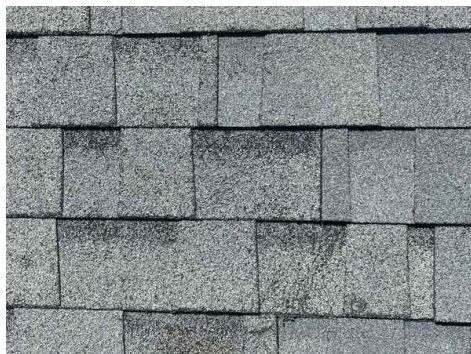
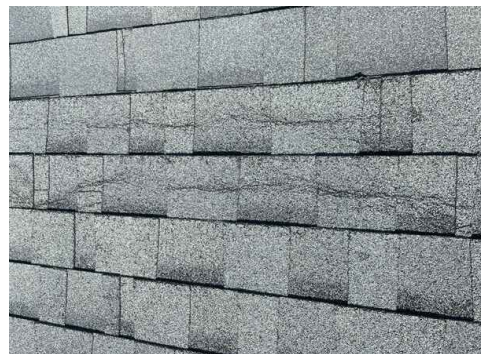
DAMAGED (GENERAL)

Roof coverings showed moderate damage. Damage appears to be from Hurricane Sally and a possible Hail Storm at some point. Recommend a qualified roofing professional evaluate and repair.

Appears to be from Hurricane Sally

Contact a qualified roofing professional.

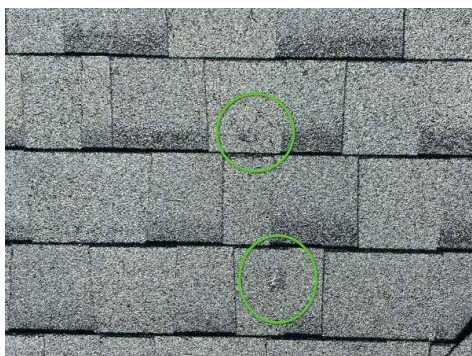
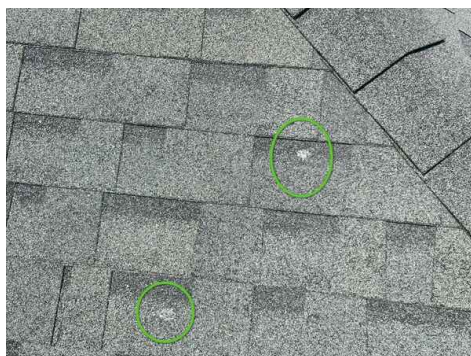
Appears to be Hail Damage (Multiple places over roof)

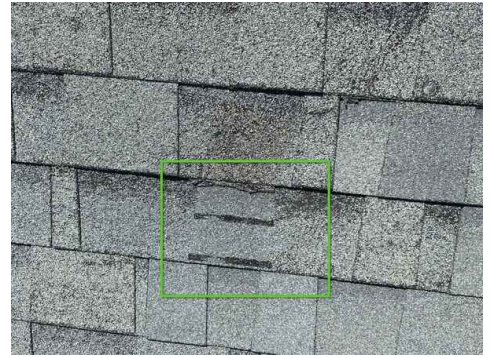
2.1.2 Coverings

SHINGLES MISSING

Observed one shingle tab that was missing. The missing piece was one the roof and was given to the current owner. This piece can be sealed back into place.

Contact a qualified roofing professional.

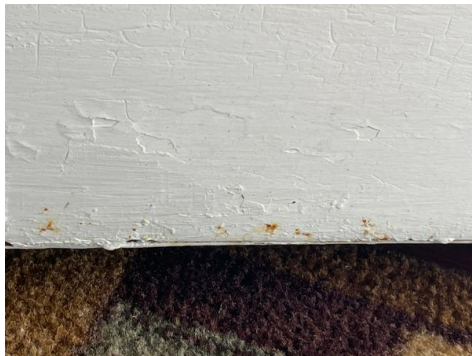
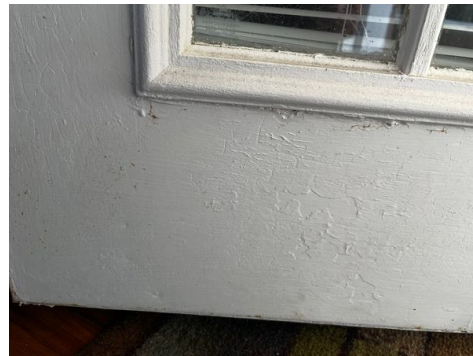
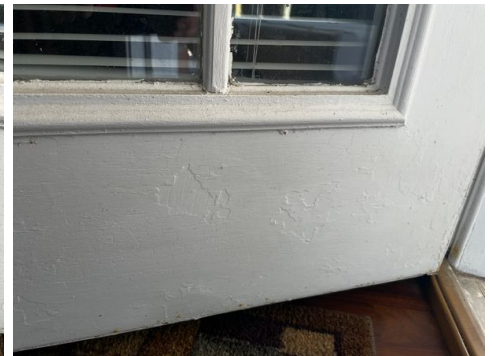
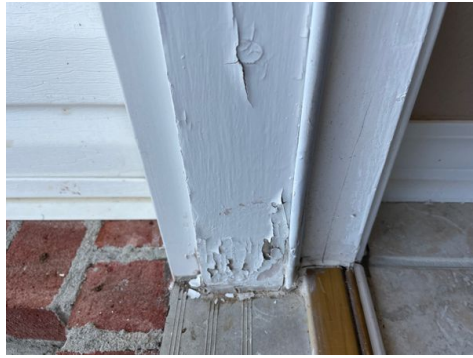
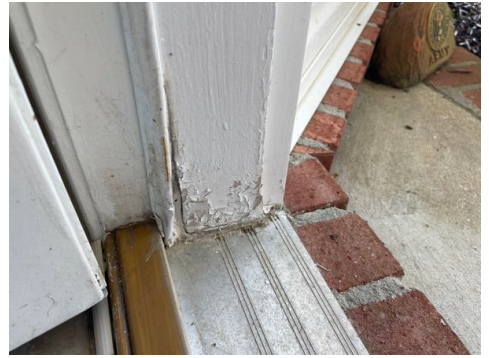
Door finish is worn. Recommend refinish and/or paint to maximize service life.

Contact a qualified door repair/installation contractor.

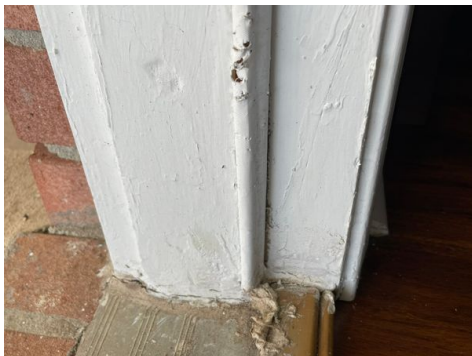
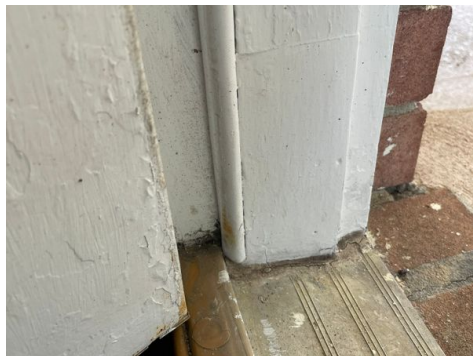
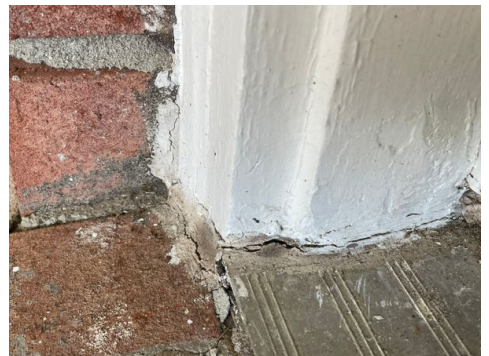
3.3.2 Exterior Doors

LOWER FRAME/TRIM - WOOD ROT

This door has signs of previous wood rot near the bottom. Door frame appears to have been repaired and painted at some point. This is very common in our area, when door are uncovered and exposed to the weather.

At this point, this is cosmetic. If this is a concern, recommend repair/replacement by Door Repair and Installation Contractor or Handyman.

Contact a qualified door repair/installation contractor.

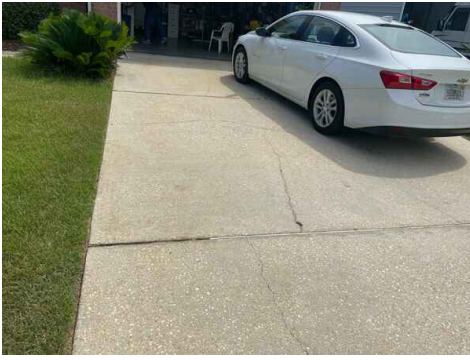
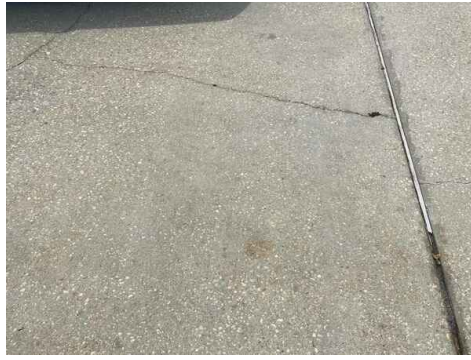
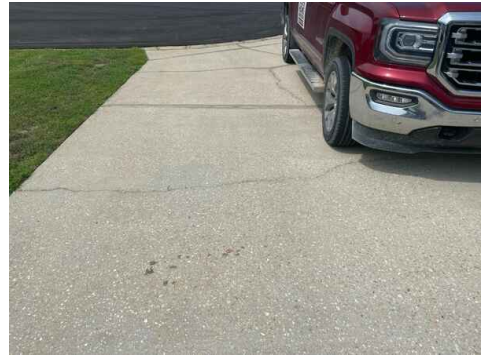
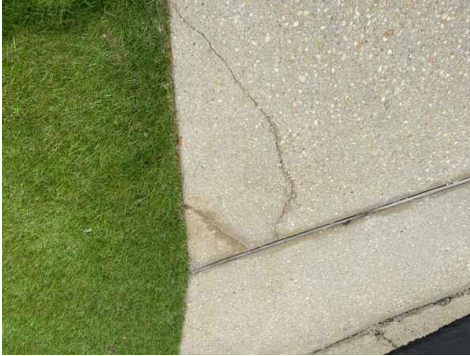
3.4.1 Walkways, Patios & Driveways

DRIVEWAY CRACKING - MINOR

Minor cosmetic cracks observed, which may indicate movement in the soil. Recommend monitor and/or have concrete contractor patch/seal. These are very common in our area.

Contact a qualified concrete contractor.

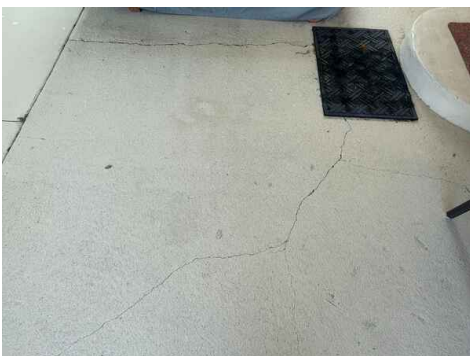
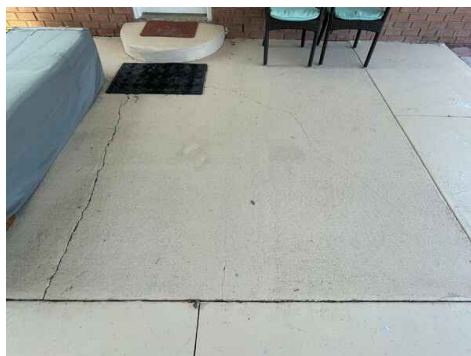
CRACKED CONCRETE

There are several cracks in the concrete on this porch. These are very common in our area. These are mostly cosmetic for now. If a concern, recommend evaluation by a licensed Concrete Contractor.

Contact a qualified concrete contractor.

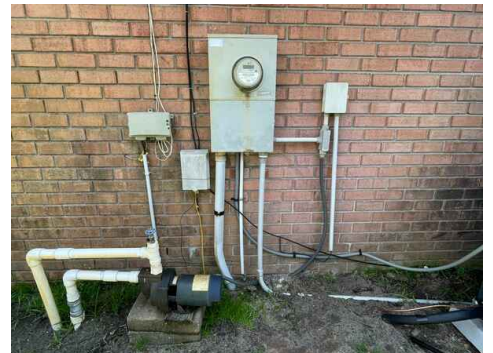
NOT INSPECTED

The Main Entrance Conductors are enclosed in electrical conduit and can not be visually inspected.

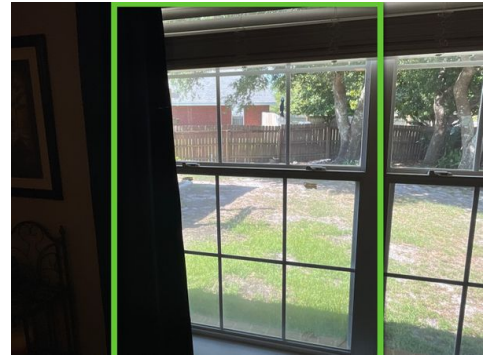
6.3.2 Windows

Repair Needed**WINDOW WILL NOT STAY OPEN**

The window springs appear to be damaged. Window will not stay open. This could be an egress issue in the event of an emergency. Recommend evaluation by a reputable window install/repair contractor.

Contact a qualified window repair/installation contractor.

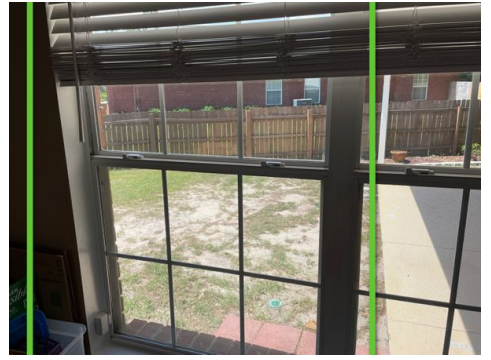
DAMAGED

One or more windows appears to have general damage, but are operational. Recommend a window professional clean, lubricate & adjust as necessary.

Left window damaged, right window in good condition for age.

Contact a qualified professional.

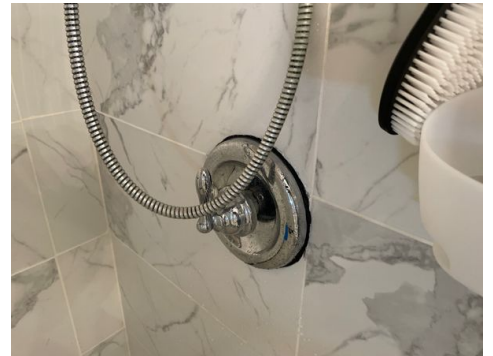
Repair Needed**FAUCET VALVE ADJUSTMENT**

The valve appears to need adjustment. The hot and cold positions are out of alignment. Recommend evaluation by a licensed plumbing contractor.

Contact a qualified plumbing contractor.

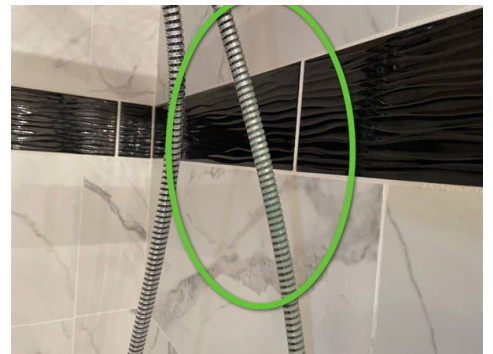
10.2.2 Shower

Maintenance Item**SHOWER HEAD - LEAKING**

The handheld showerhead hose is leaking and may need to be replaced.

Contact a handyman or DIY project

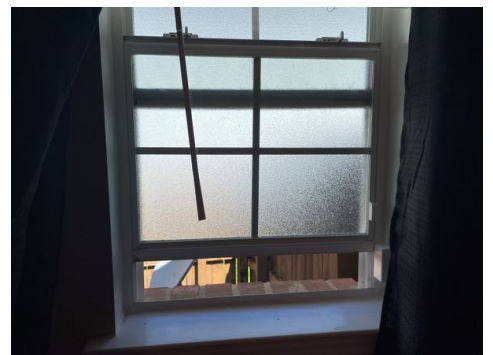
10.3.1 Windows

Repair Needed**DAMAGED**

One or more windows appears to have general damage, but are operational. Recommend a window professional clean, lubricate & adjust as necessary.

Contact a qualified window repair/installation contractor.

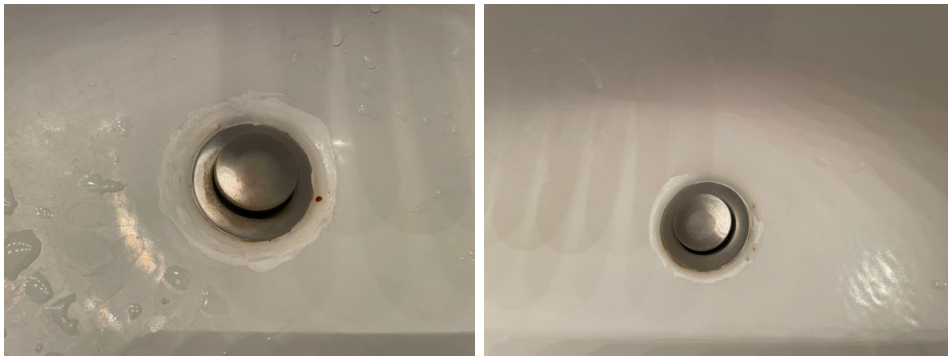
PORCELAIN CHIPPED AND STEEL SINK RUSTING

The porcelain coating is chipped and the steel sink is rusting. May need to be replaced at some point.

Both sinks have been repaired/painted around the drain.

Recommend repair/replacement by a plumber or handyman.

Contact a qualified plumbing contractor.

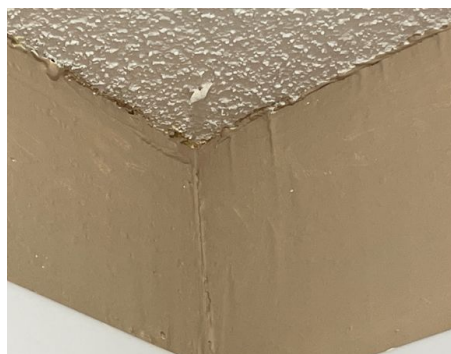
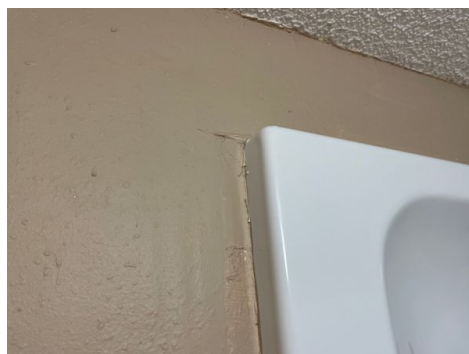
Small drywall patching around shower

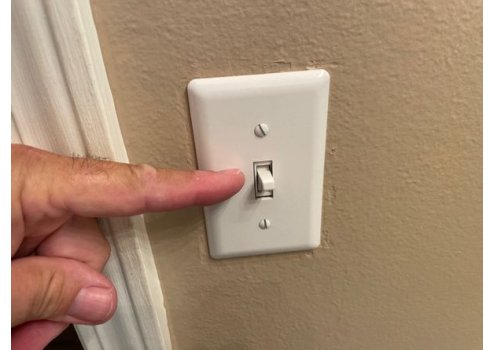
LIGHT SWITCH - WORN/BROKEN

The light switch appears to have an internal defect and will need to be replaced. Although the light switch works, the handle is very loose and may fail at any time. recommend evaluation by a licensed, electrical contractor or handyman.

Contact a qualified professional.

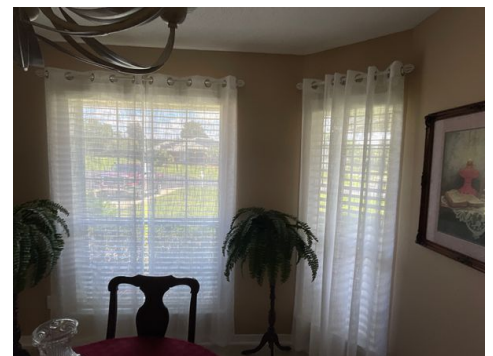
DAMAGED

One or more windows appears to have general damage, but are operational. Recommend a window professional clean, lubricate & adjust as necessary.

Contact a qualified window repair/installation contractor.

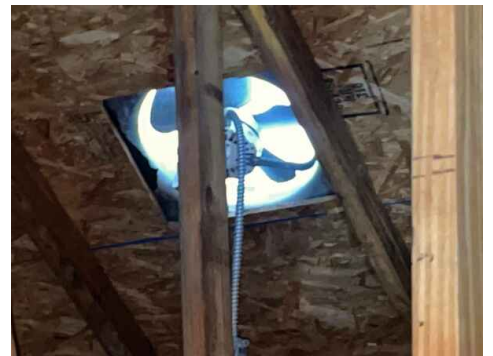
Fan was not tested, this was a visual inspection only. Fan did not appear to be running even though it was very hot in the attic. Recommend evaluation by a Licensed Electrical Contractor or Handyman.

Contact a qualified professional.

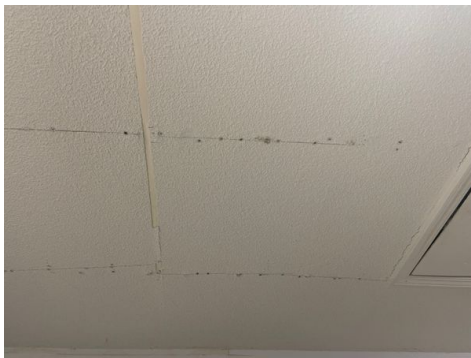
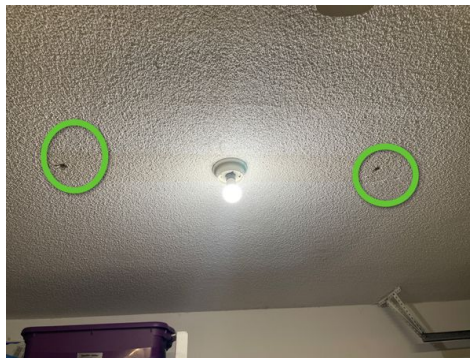
DAMAGED

Garage ceiling was damaged. Recommend qualified contractor evaluate and repair to prevent moisture intrusion.

Contact a qualified professional.

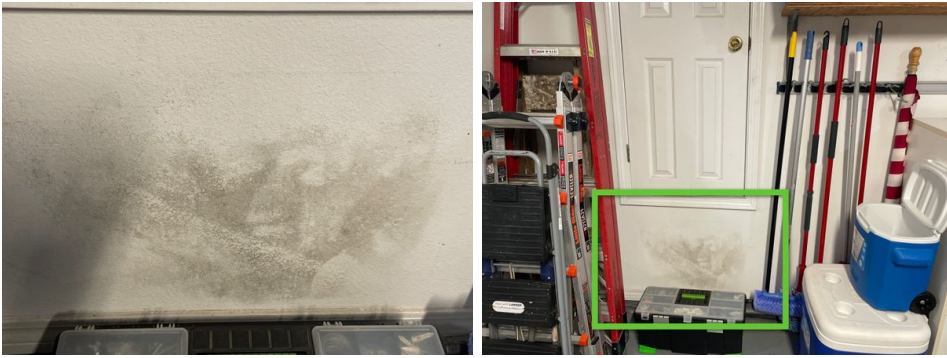
18.3.1 Walls & Firewalls

MILDEW PRESENT

There is a small amount of mildew on the wall below the HVAC closet. Recommend cleaning and observing for moisture buildup.

Contact a qualified professional.

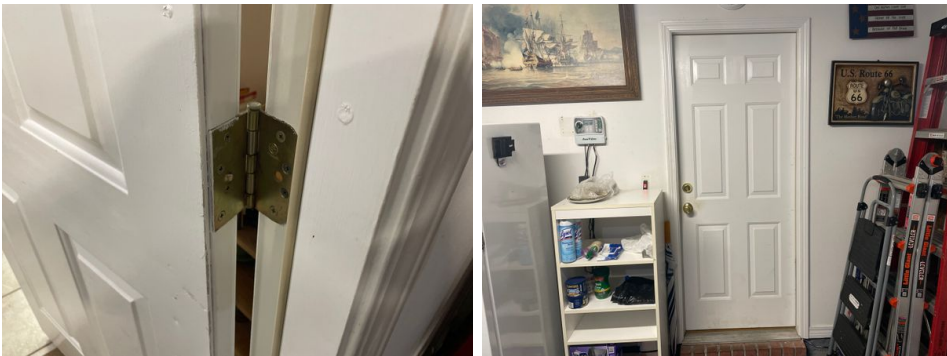
18.7.1 Occupant Door (From garage to inside of home)

NOT SELF-CLOSING

Door from garage to home should have self-closing hinges to help prevent spread of a fire to living space. Recommend a qualified contractor install self-closing hinges.

Contact a qualified door repair/installation contractor.
