# Rolfs Home Inspection LLC

**January 4th 2023, 12:00 pm**

**BUILDING ADDRESS:** 1234 Country Club Drive  
**CITY:** Anywhere  
**STATE:** Florida  
**ZIP CODE:** 55555  
**INSPECTION DESCRIPTION:** Whole Home  
**SQUARE FOOTAGE:** 1735

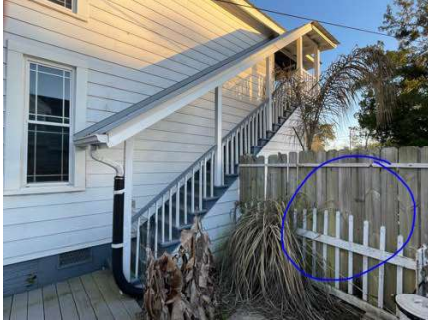
### **GATE** Poor

There are two gates located on this property. A small walk gate on the right side of the house, opens, but drags the ground. The double drive gate on the left-hand side of the house was blocked and could not be inspected.

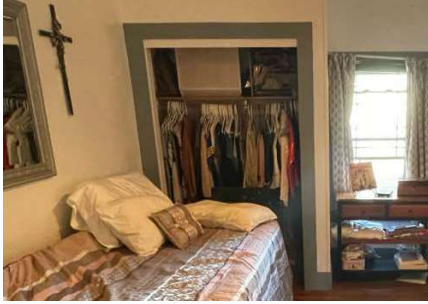
There's a small closet with a shelf and clothes hanging rod. The rod needs some reinforcement as it is sagging. There are no doors on this closet. The doors are located behind the couch.

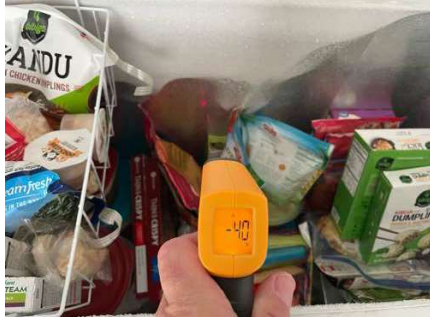
Refrigerator was unplugged when inspector arrived. Inspector plugged refrigerator in and tested and then unplugged refrigerator again. Refrigerator temperature tested at 48.7°F and the freezer tested at 2.2°F. deep freeze was also tested and it was -4°F.

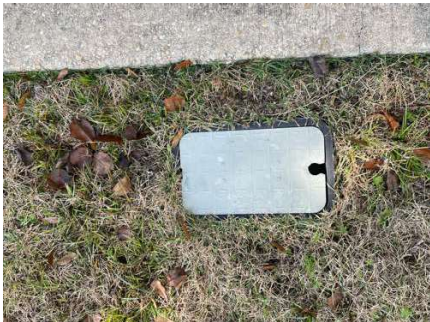
Main shut off is located next to driveway on the left side of house. Valve is covered in dirt and was not actually tested by inspector.

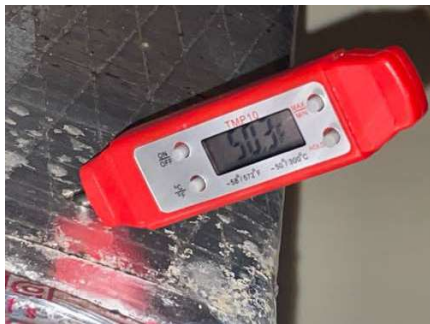
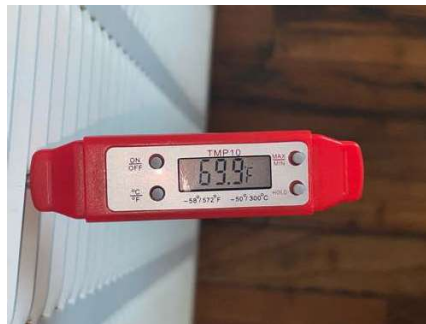
### **COOLING SYSTEM OPERATION** Satisfactory

Cooling system tested by a normal operational means. The temperature differential for the cooling system was 19.6°F.
